# ARGOS HILL WINDMILL

## How She Worked

## Mill Tour Guide Information & Technical Details

*Third Edition  
2023*

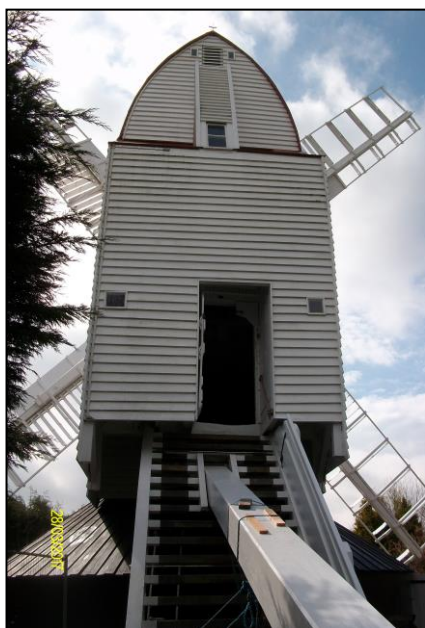
The picture above shows the rear of the mill with the tunnel covering the ladder access to the bin floor, the rear extension, main steps and tailpole. The sack slide can be seen attached to the right side of the steps. Note the doorway is offset to the right to ease access from the steps.

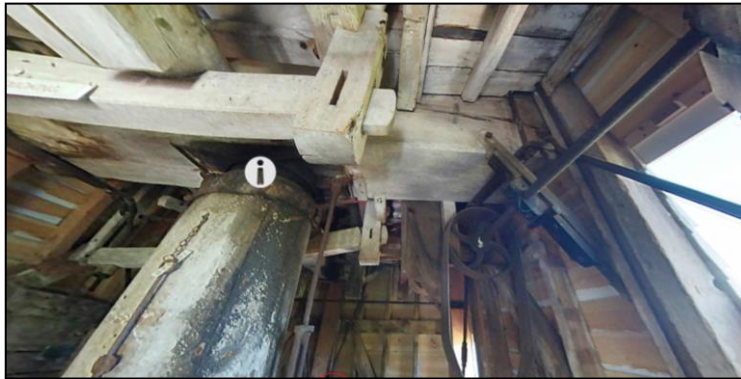
The lowest level of the mill itself, the spout floor, is accessed from the steps at the rear. Here, the meal was collected from the stones in the bins on the left, and output from the wire machine and smutter spouts collected in sacks.

Most of the mill functions can be controlled from this floor via extended ropes and cords. The tentering gear, main post and samson head which supports the mill structure are also visible on this floor (see picture).

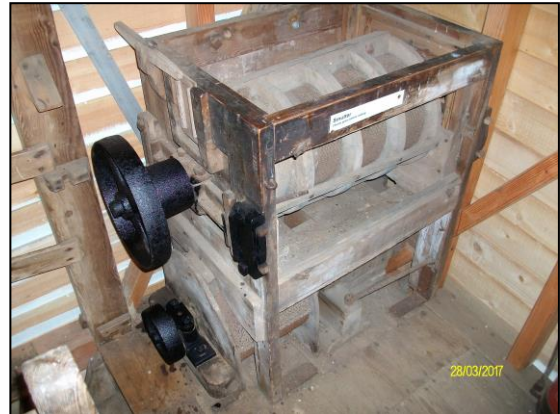
The smutter (see right) is used to clean the grain before milling, removing dust and harmful fungal growth which may arise from storage in damp conditions. It is fed from the rear right bin above via a chute and a small shuttered inlet that can be seen on the front of the machine (see right) above the drive pulley. It was driven from the tail wheel via a side pinion, shaft and pulley belt on the right side of the stone floor. A small cord operated wooden rocker allows the smutter inlet to be opened from the spout floor below.

The smutter has a horizontal wire mesh drum with internal rotating brushes that sweep the dust out through the wire mesh, allowing clean grain to fall out of the far end of the drum via a spout into a grain sack on the floor below. The dust is drawn into the smutter box below the drum by a fan driven by a secondary drive belt, and is then blown out of the side of the mill.

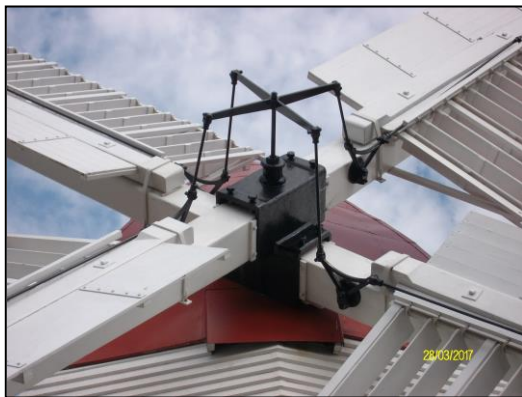
Power to the stones is provided by patent sweeps (sails) (see left) that are mounted on long beams (stocks) that pass right through the cast iron canister. These were originally wood (pitch pine) but are now hollow steel sections for strength and durability (broken stocks were a fairly common problem in old windmills). On to these are bolted the sweeps, with the main member (whip) carrying a framework of battens to support a set of shutters. These are set at an angle to the plane of rotation (weather) to produce the turning force. A reduction in this angle of weather along the length of the sweep ensures that the ends of the stocks that support the sweeps are not subject to excessive bending force and turbulence is reduced. There is space for 16 short shutters on the leading edge at the far end of each sweep, and for a total of 35 longer shutters on the trailing edge.

Thus, the sweeps have space for a maximum of 51 shutters each, but at present carry fewer to reduce the strain on the structure while the mill is inactive and cannot turn. The shutters are attached perpendicular to the whips with angled cranks which allow them to be opened and shut, or set at some intermediate angle. When they are closed, maximum torque is produced on the windshaft, but when opened (fully or partially), wind is spilled and torque reduced. Solid windboards on the inner ends of the sweeps provide a minimum turning force to turn the sweeps when off load, so the braking system must be able to resist this force in high winds.

The cranks are all connected to shutter bars which move longitudinally on the stocks to open and close the shutters. These are operated simultaneously from a cross piece at the centre of the sweeps called the spider, which is mounted at the front end of a push-rod that passes through the centre of the windshaft to a rack and pinion at the tail end. This in turn is operated from the large chain wheel mounted on the side of the mill that is turned by a loop chain passing down through a box section, allowing the shutters to be opened and closed by pulling down on either side of the striking chain on the spout floor. A suitable weight can be attached to the chain so that, if the wind becomes too strong, the pressure on the shutters will raise the weight allowing the shutters to open and spill the wind automatically. Conversely, when the wind drops, the weight will close the shutters again. This system is collectively known as the striking gear; it allows the speed of the sweeps to be controlled without having to stop them.

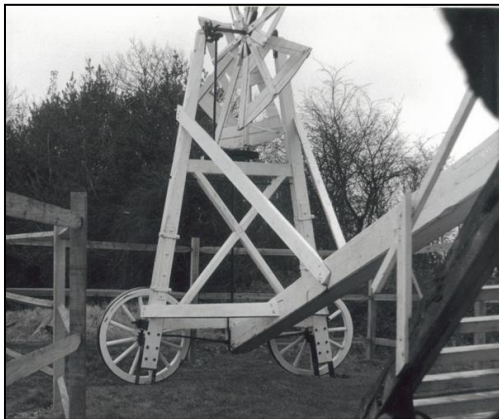
The mill is designed to move into the wind automatically; this had to be done by hand in older mills. A fantail carriage is attached to the tail pole that projects from the rear of the mill. It carries an eight-bladed fan that drove a set of cartwheels via bevel gears, shafts and reduction gearing, following a circular track round the mill. When the mill is facing into the wind, the fan and buck remain stationary; if the wind veers to one side, it catches the fan, driving the wheels such that the buck faces into the wind again, and stops. The fantail also serves to stabilise the mill by bracing the buck against the force of the wind.

*The picture left shows a previous rebuild of the fantail. The cartwheels are unusual, in other mills they are cast iron.*

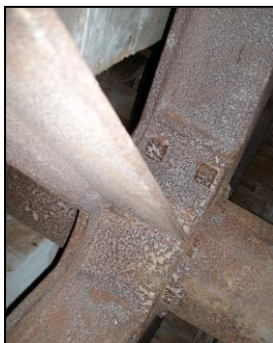
The windshaft is a massive cast iron tube with an integral poll end (canister) through which the stocks pass. The open neck (front) bearing is about 12" in diameter, resting on a gunmetal (bronze) semi-circular block. This sits on the weather (breast) beam, which therefore carries most of the weight of the windshaft and sweeps. The tail (rear) thrust bearing is about 6" in diameter (see right) and bolted to the tail beam. It has a sliding contact connected to the lightning conductor which runs down the rear of the buck.

The drive from the windshaft is taken off the brake (breast) wheel and tail wheel, both about 8 feet in diameter with cogs made of hard wood (apple or hornbeam). The cast iron brake wheel lies just behind the neck bearing and is of compass arm construction (with radial spokes) in two halves bolted together and retained with iron wedges around the windshaft (see left). The brake wheel has a large wooden (elm) brake shoe mounted in linked sections around its rim that is operated by a long wooden lever on the right of the stone floor. When the mill is running, it is supported in the off (up) position by a hook and pin. Unhooking and dropping the brake lever pulls the brake shoe on; a heavy weight can then be hung on the brake lever to hold it on. The brake can be operated from the bin floor below by a rope extension. It must be applied carefully when stopping the mill to avoid overheating of the brake shoe, or, worse still, snapping off the stocks.

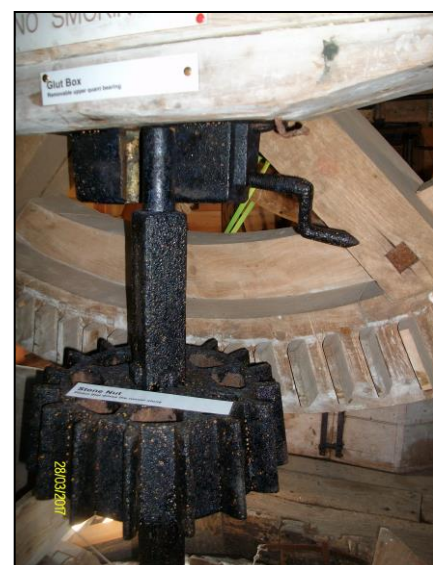
The tail wheel is of clasp-arm construction of oak and elm: two pairs of cross pieces are clamped around a square section of the windshaft supporting a wooden rim made in sections (felloes). The cogs are made with shanks that extend right through slots in the rim to be retained by small pegs. These wooden cogs engage with smaller cast iron pinions mounted on vertical square shafts (quants) that drive the upper runner stone. The gearing ratio means the runner stone rotates about twice per second.

The combination of wood and iron teeth provides quiet running with minimal need for lubrication. The wooden cogs are to some extent self-adjusting, since high spots will wear away, and improve meshing, but they then need regular replacement. The stone nuts can be disengaged from their upper bearing (glut box) to disconnect the drive by inclining the drive shaft away from the tail wheel. This serves to protect the fragile wooden teeth on the drive wheels in case the brake does not hold, as well as selectively disabling the stones. A screw clamp on the glut box retains the upper quant bearing in its working position. The runner stone rotates on a spindle and thrust bearing mounted below on the bridge tree, but is driven from above by the quant. Hence the runner stone is 'overdriven' while its weight is carried on the bearing below.

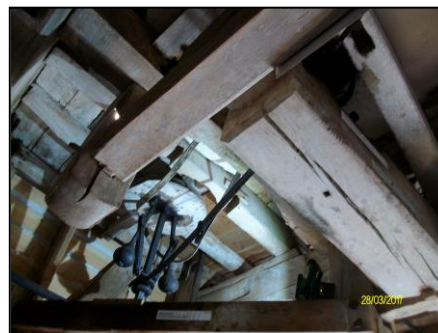
A major refinement to the milling mechanism uses a governor to control the separation of the stones to compensate for variation in the wind strength and resistance to the rotation of the stones. This tentering gear can be seen from the spout floor, fitted below the stones. The governor on the tail stones is driven by a leather pulley belt from the stone spindle, so it rotates at a speed proportional to the runner stone, with a gearing ratio of about 0.5, giving a speed of around 1 rev/sec. A pair of lead weights is attached to lever arms and a collar, which is raised as the stone speeds up. The collar engages with the forked end of a long wrought iron arm (steelyard) which crosses below the stones and is pivoted through a steel loop.

The other end of the steelyard is connected to an adjustable screw which passes down through the brayer, a beam that supports one end of the bridge tree, which in turn supports the bridging box and runner stone spindle. The other end of the bridge tree is mortised into a supporting beam allowing a small amount of rotation. The weight of the runner stone (over one ton when new), plus the quant and stone nut, is thus supported by this system of levers with a large mechanical advantage, so it can be held up by a small downward force (less than 10kg) at the end of the steelyard, provided by the lead weights. A movable hook on the steelyard is also provided for an additional adjustable balance weight.

When stationary, the runner stone is slightly raised. This allows the sweeps to start with reduced loading, helping to overcome the inertia of the runner stone. As the mill speeds up, the governor weights fly outwards raising the collar; the upward movement of the steelyard fork produces a small downward movement of the runner stone, bringing it into the working position. As grain is fed in, the resistance will increase and the speed decrease; the governor can raise the stone to maintain speed. The tenter-screw must then be adjusted for optimum meal quality, giving the maximum yield of flour without overheating. Assuming the working gap (nip) is about 1mm, with the governor weights in mid-range, the difference between the starting and working positions produced by the tentering mechanism has been calculated (see below) to be about 0.3 mm; that is, the gap when stopped is about 1.3mm.

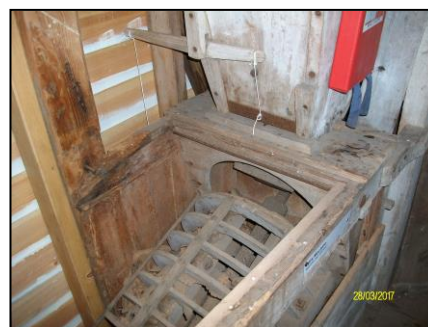
The meal produced by the milling process contains a mix of flour and bran, the remnants of the outer shell of the grain; the flour must be separated out. The wire machine (flour dresser) sieves the meal into three main parts: fine (white) flour and bran, with 'middlings' being a mixture of the two. It contains an inclined wire mesh cylinder and rotating brushes that force the meal components through the mesh (see picture). Fine flour is forced out first, then middlings, leaving coarse bran to emerge at the far end. These are collected from separate spouts for bagging on the floor below. The wire machine is driven from the tail wheel via a skew gear and inclined shaft which can be disconnected by a lever. Its inlet spattle (shutter) can be opened from the spout floor below via a rocker and cord.

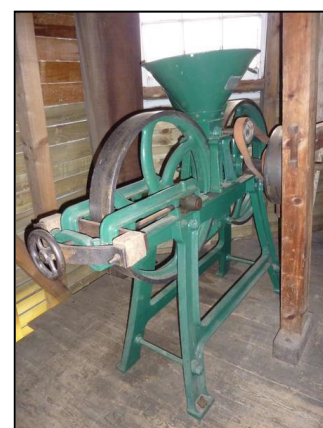
Mountings for an auxiliary machine are present on the spout floor of Argos Hill Windmill. It has an elaborate drive system taken off the tailwheel by a side pinion with lever engagement, crown gears, shafts and pulley drive. The most likely candidate for this missing machine is an oats roller mill. These are still present in several other local mills. The overall dimensions, spacing of the mountings and position of the drive shaft on this machine appear to be consistent with those seen on the spout floor. A hatch above the machine position is aligned with the outlet of the middle right grain bin, which probably contained oats to be fed to the stones or the roller machine.

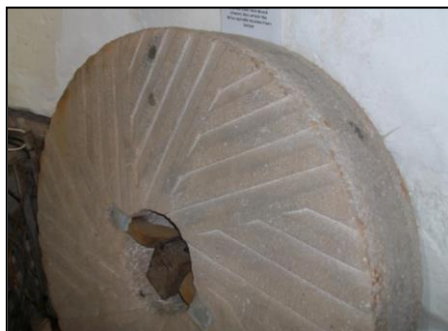
The spare runner stone displayed at Argos Mill is shown left. The yoke and mace upon which it rotates can be seen at the centre. It is cut with a set of 10 harp shaped sectors, with the furrows running diagonally. When rotating upon a bedstone dressed in the same way, the furrows cross over in a scissor action which crushes the grain on the sloping edge of the opposing furrows to release the flour without grinding the husk.

The orientation of the furrows in Peak stone shown above indicates that it rotated in a clockwise direction, unlike the stones at Argos Mill, which rotate in an anticlockwise direction. For milling flour, burr stones are cut with additional fine grooves on the lands between the furrows, called stitching, to provide extra abrasion of the meal. A straight edge would be used to check the profile, with red ochre smeared on it to mark the high spots to be removed. Ideally, the runner stone should be slightly concave so the edges are as close together as possible with actually meeting.

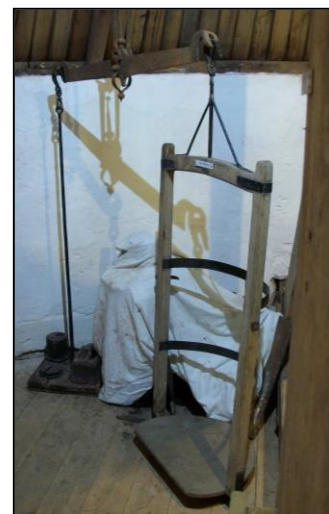
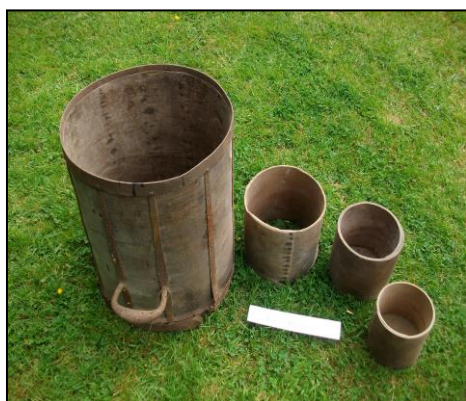
The sack balance has a set of weights of  $\frac{1}{2}$ , 1, 2 and 4 stones, but these may not be original. A smaller balance was also found in the mill, probably used for flour sales in small volumes.

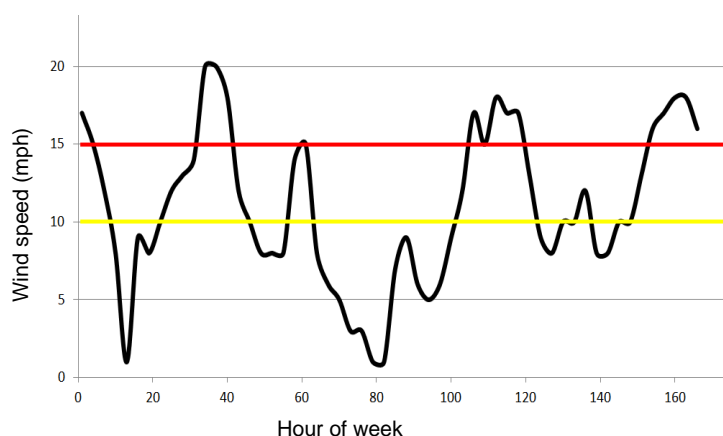
This data was plotted out in the graph left to illustrate the wind variation over the whole week. The red line indicates the wind speed assumed to be required for milling, while auxiliary functions of the mill could be carried out at lower wind speeds, indicated by the yellow line. The smutter and wire machine and later in the life of the mill, the oat crusher, could operate when the power produced by the sweeps was lower than that required to drive the stones. This would extend the working hours, and there would be regular maintenance to do during calm weather. If the miller carried out his own stone dressing, this could also be fitted in, whereas, if an itinerant was used, this would be more difficult to fit into a calm period.

Night-time hours are assumed to be between 19.00 and 7.00 hours, shown in blue in the table. If necessary, the miller must work day or night, for the wind is just as likely to be blowing at night. There would be more daylight in summer, but unfortunately there tends to be less wind during this season, when high pressure is more frequent. This spring sample period would, however, tend to be windier than average.

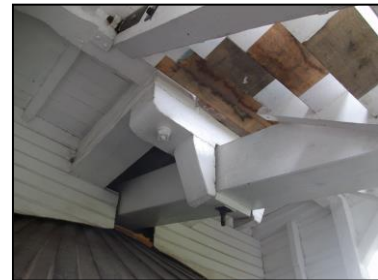
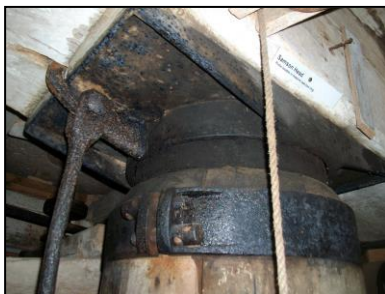
This weight on the weatherbeam is counterbalanced by the tailpole and fantail at the rear of the mill. The tailpole is attached to the sheers, heavy beams that run front to back under the spout floor either side of the main post. These are clasped around the main post by cross pieces that are moulded to form a circular collar around the main post to stabilise the buck. The tailpole has a large tenon inserted into a rear cross beam and supported at the required angle by a yoke and retained by large bolts (see right). The sheers are supported at their centres by vertical wrought iron tie bars tensioned with turnbuckles hanging from lugs on the Samson head (sheer hangers). In addition, diagonal sag irons attached to the ends of the crown tree support the corners of the buck (see below), plus the frame incorporates numerous diagonal compression braces.

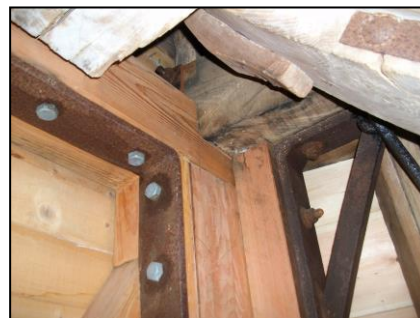
Above: Reinforcing brackets fitted to the top of the left breast corner post. The earlier cast iron bracket (1925) to the right supports the end of the weatherbeam. The new wrought iron bracket on the left supports the junction of a new timber corner post and upper side girt installed in 2015.

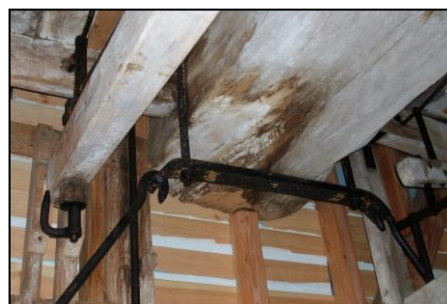
Above: Clamps on the end of the crown tree providing attachments for the diagonal tension rods that resist sagging at the front and rear of the mill body.

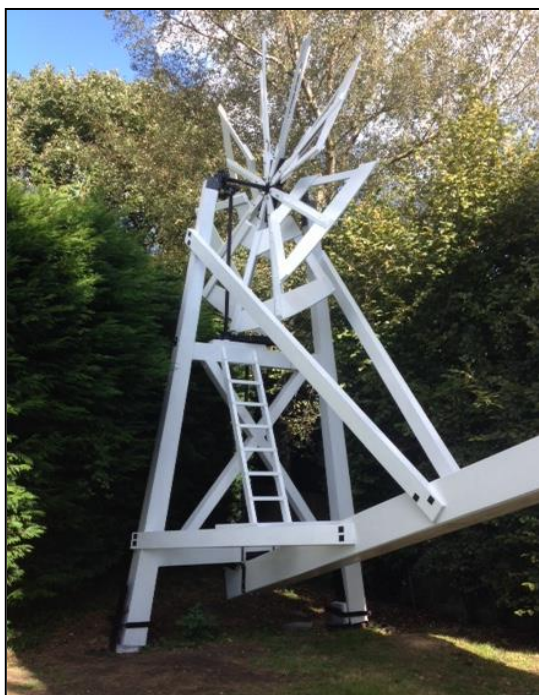
Restoration of the fantail as shown left was completed in September 2018. At this stage it did not include the wheels and their drive shafts, since the turning circle could not be reinstated at this time.

The new fantail was constructed according to detailed, dimensioned drawings made of the old frame which still existed in decayed form at the start of the project. Some of the previous fantail remnants were retained for reference, such as the complex rebated joints.

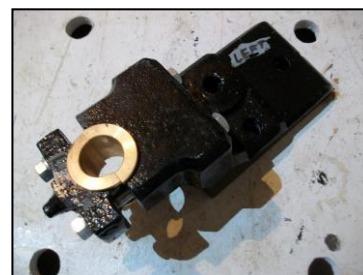
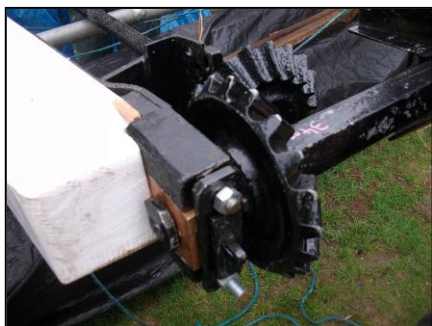
The main vertical framework (posts and crossbars) was initially constructed horizontally, and with the mortises drilled and then chiselled out by hand. The hub shaft and the upper vertical drive shaft were then offered up but did not mesh correctly; an extension to the bracket supporting the top of the vertical shaft was required to bring the crown gears into mesh (see picture below).

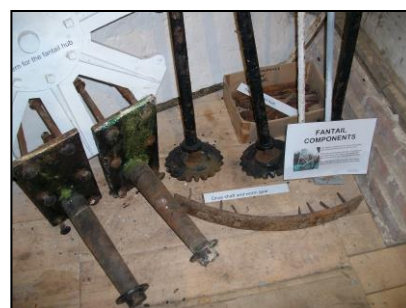
The fantail wheel axles, drive shafts and a segment of original iron tyre are shown right prior to reassembly.

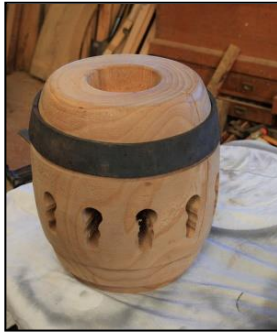
The fantail wheels are massively constructed in the manner of traditional gun carriage wheels to bear the weight of the fantail. The hub (left) is turned from elm because it has a complex grain which resists splitting in any one plane. It is reinforced with wrought iron bands and mortises cut for the spokes. Twelve spokes are cut from ash, which has a straight regular close grain that resists bending.

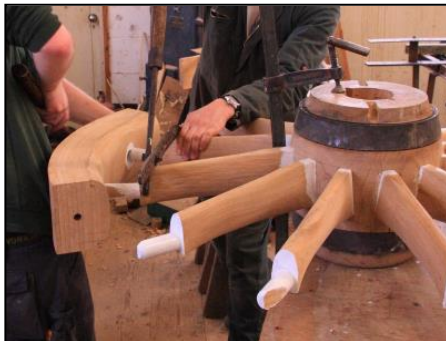
These are finished with a spokeshave and glued and hammered into the hub (right). The rim is formed from layers of oak boards that have to be steamed to make them flexible and glued together in sections called felloes. Each of six felloes are glued onto the ends of a pair of spokes to make up the rim (below).

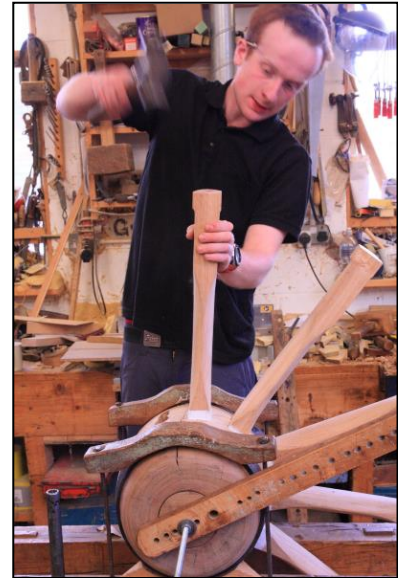
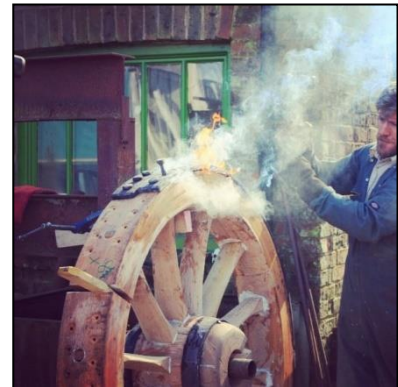
The felloes are held together by heavy wrought iron strakes that are fitted hot to draw the sections together when the iron cools. These are fixed using large square cut nails that are also hammered in hot (right).

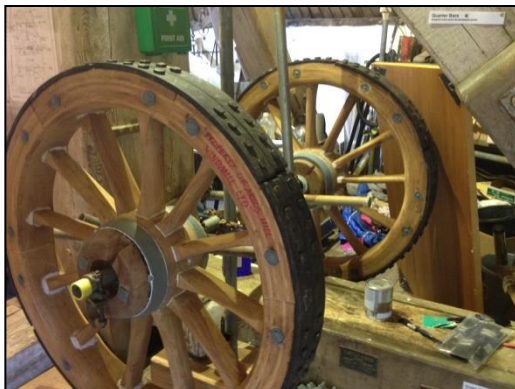
The finished wheels are shown below mounted in the roundhouse at Argos Hill ready for painting. Note the felloes are reinforced with rivets to resist lateral splitting. The square nails provide grip when the wheels are driven around the turning circle.

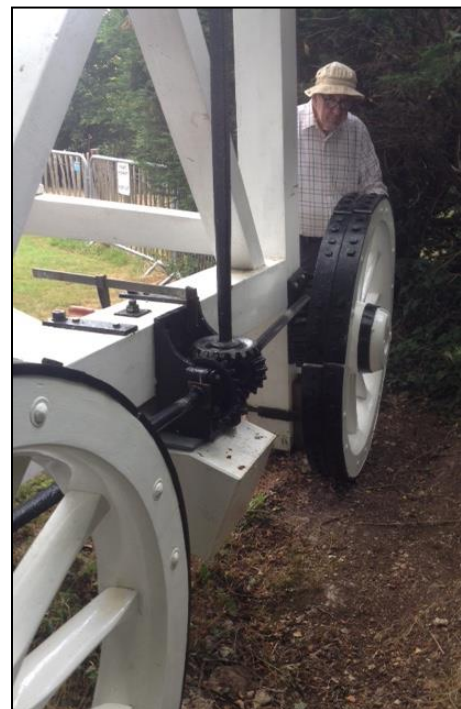
The wheels were painted white and the driving skew gears bolted onto the hubs, and, in 2022, the wheels were refitted to the fantail carriage (right). The stub axles have projecting webs that required slots to be chiselled in the legs of the frame; they could then be fixed with screw bolts and the wheels mounted. The split drive shafts are terminated with worm gears that engage with the hub gear, with the ends supported in bearings attached to the outside of the leg. These are right and left handed so that the wheels rotate in the same direction. The position of each component needed to be carefully adjusted for correct function of the drive system.

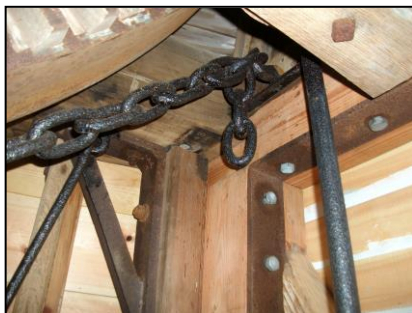
The picture left shows the fixing chain and connecting rod of the brake at the front of the stone floor.

The brake shoe is formed of a set of elm brake shoes mounted around the rim and hinged together with wrought iron plates. The lower end is attached to the upper side girt via a heavy chain, while the upper end is attached to the brake lever below via a wrought iron rod. This long wooden lever is pivoted at the front of the mill so that the brake is applied when the far end is held down, when the shoes are tightened onto the cast iron brake wheel rim.

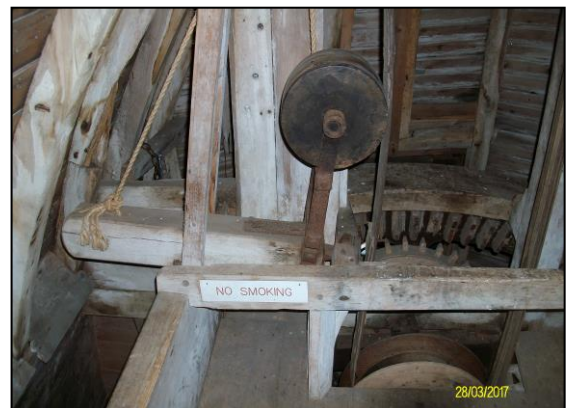
The picture above shows the sack hoist mechanism with the jockey wheel, crank and rope on the left, and the top of the brake wheel, drive gear, pulley and belt on the right.

The pinion that engages with the brake wheel has hardwood teeth mortised into a solid elm hub that are retained by wire nails through the shank ends. Prior to repair, it had numerous broken teeth, so all were renewed in applewood, the cracks in the hub filled with resin and the whole coated in PVA to preserve and reinforce the teeth. Refitting this gear necessitated the removal of its square shaft, which allowed its bearings (hardwood blocks) to be checked for soundness and lubricated. A new hardwood bracket was installed to support one end of the beam upon which the forward bearing is mounted using a screw bolt, so the height of the drive pinion could be easily adjusted. The pinion was then refitted with new wedges, square on the shaft to ensure consistent meshing with the brake wheel cogs, and was successfully tested by manual operation of the sweeps.

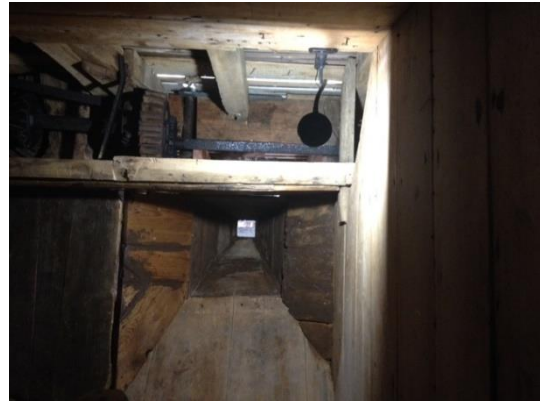
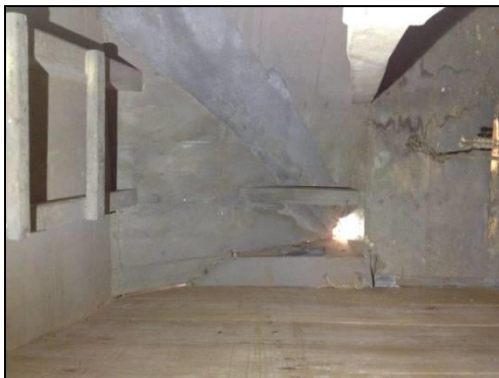
The partly restored smutter bin is shown right, with the spout below and the smutter drive compartment above. The spout itself was removed and repaired as a unit, and refitted to be removable by cutting through its main supporting beam, which can now be slid out to remove the spout as required. The surrounding boards were repaired extensively with acrylic filler and PVA to stabilise the decayed timber. The auxiliary drive is seen in the upper part, later covered with recovered boards. The vertical sides were usable after treatment with preservative. The form of the bin was modified with a platform to stand on to facilitate access to the gear train. All repaired sections of board were made removable for access and repair.

Only **smutter (grain cleaner) bin** needed extensive repair, all the others basically sound. In order to access the auxiliary drive for repair, the sloping lower boards around the spout were stripped out of the smutter bin. Many were decayed or missing in any case, and some of the framing also needed repair. The boards covering the drive gears had been replaced with sacking, perhaps to facilitate access to the smutter drive gears.

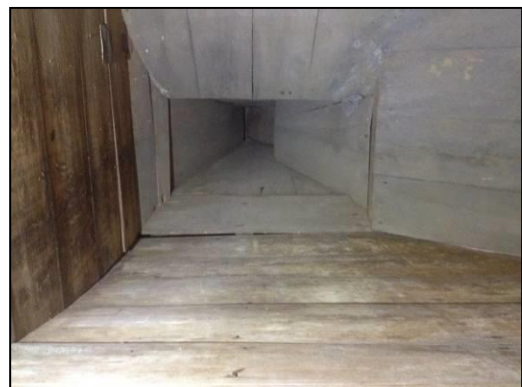
The **wheat bin** (left) occupies the front left corner of the mill, with an access ladder and relatively small spout with sliding spattle. This feeds the tail stone hopper via an open chute that incorporates a sieve in its floor to remove dust, which had been restored earlier.

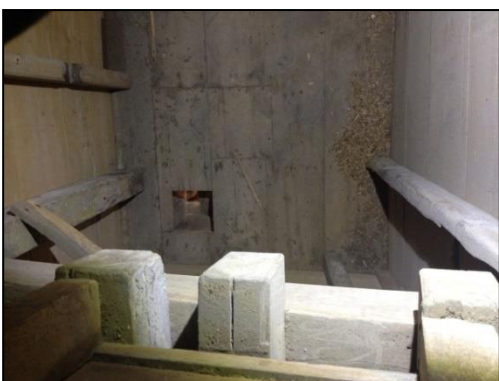
The **flour dresser bin** (right) has a long spout which feeds directly into the dresser drum, with a sliding spattle and agitator to control the feed rate.

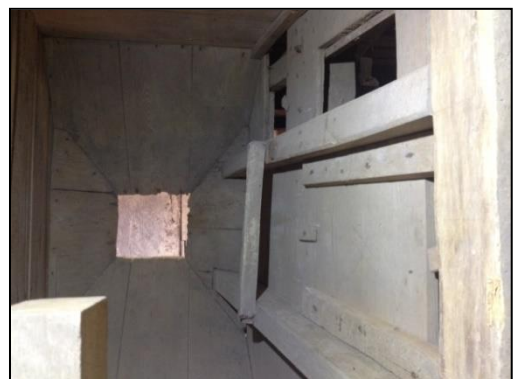
The **grist bin** (left) has a flat floor providing extra capacity and ease of access. A large square aperture has a sacking spout feeding the peak stone hopper below at a relatively high rate with animal feed such as barley and oats.

The **crusher bin** (right) is a subdivision of the grist bin with a large aperture which is assumed to feed an oat crusher on the spout floor via a long sacking spout which passes through a hatch in the stone floor. The sacking spouts could be easily controlled by a wrap-around chord.

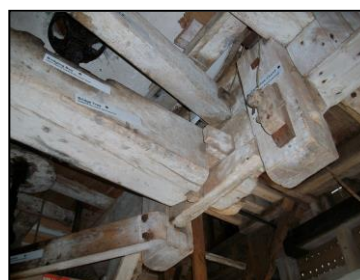
Underside of the bridge tree which supports the tail runner stone that can be seen above, its end mortise supported by a pair of hangers and cross bar. This is all original oak. Note the wedges used to retain the bridge tree tenon.

Part of the tentering gear of the tail stones is shown left, with the brayer end and adjusting screw visible. This is attached to the end of the steelyard, which is suspended on a nearby loop, creating a lever with a large mechanical advantage to support the weight of the runner stone.

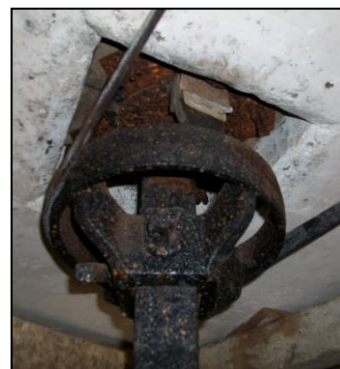
The French burr bedstone has a square eye (see picture right), as might be expected in stones assembled from separate pieces of quartzite. The bearing is retained by a square hackle plate fixed with wingnuts, these, perhaps, being a later modification. It is retained by a characteristically shaped single scooped wooden wedge with a hole in the handle to aid extraction when the bearing needs servicing. The square neck box would typically be packed with gun cotton or shredded twine soaked in grease for lubrication.

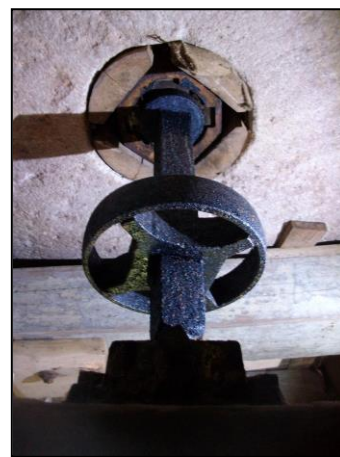
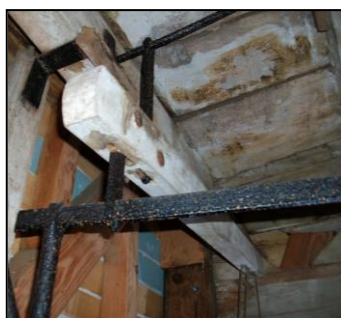
The peak stone has a circular eye (see below right), with the neck box retained by four suitably formed wooden segments around a central cast iron mount for the four hardwood wedges that form the bearing surfaces. This neck bearing appears to be of a more sophisticated design than that seen in the French burr bedstone, probably part of a later upgrade.

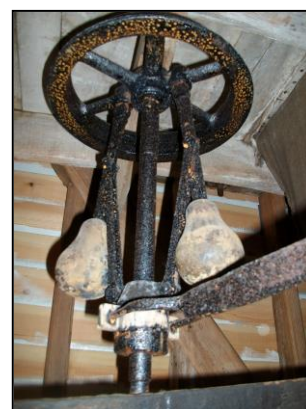
The governor on the tailstones (left) is probably original, since it has a wooden pulley and arms that are relatively crudely constructed using standard wrought iron bar, such as might be produced by the local blacksmith. The collar, however, appears to be a higher quality manufactured casting, perhaps a standard component.

The governors on the breast and tail stones also provide evidence of progress in the design of milling gear. Both have an upper drive pulley with a flange on the lower edge to retain a 1" belt driven from a cast iron pulley on the stone spindle. As they rotate, the weights fly out and raise the collar and consequently the steelyard end yoke that controls the runner stone height via the tentering gear.

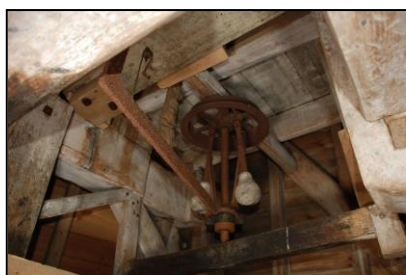
The breast stone governor (right) appears, on the other hand, to consist entirely of manufactured components. The drive pulley is cast iron, with integral mounts for the weight arms. The collar bearing is also of a more sophisticated design, with the steelyard yoke arms retained in lugs clamped around the sliding collar.

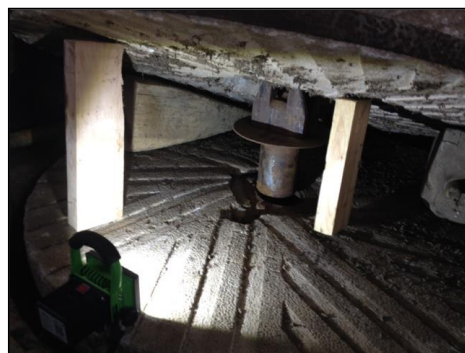
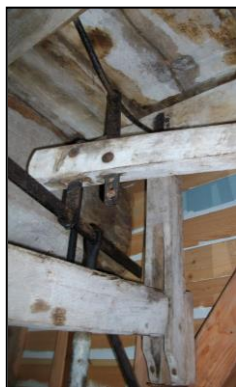
The bridging box (above) consists of a square iron casting with set screws on four sides, which allow the spindle footstep bearing to be precisely positioned within it, in order to level the runner stone. A gunmetal block supports the hemispherical lower spindle end in a matching recess incorporating a slotted oilway on one side. It was removed for restoration off site. The bridge tree at the brayer end was moved to one side so that a jack could be applied to the bottom of the spindle via a scaffold pole of suitable length. This successfully forced the spindle neck out of its bearing (right), which could now be inspected, sandpapered to remove rust and oiled. In the meantime, the bridging box had been refurbished, lubricated and refitted, and the spindle could then be dropped back into its housing and could now be rotated freely.

The brayer screw end was impeded by the sag iron attached to the crown tree end that supports the lower front left corner of the buck. It was decided to move the brayer end to the other side of the sag iron (see left), with the brayer slide to be repositioned accordingly and more securely attached. To prevent the tentering screw handle fouling the sag iron when screwed up, a sleeve, made of steel tube, was inserted between the screw handle and the brayer end, and the screw hanger repositioned away from the sag iron by drilling a new hole in the brayer end. This was possible as the manual tentering lever hanger is mounted on a slide rod, allowing it to be repositioned. This has two pulleys in its far end, allowing a cord to be looped around a static pulley mounted on the corner post and tied off to a wooden cleat. Its wrought iron hanger already had a set of bolt holes which allowed a higher position to be selected. The position of the oak brayer hanger at the bridge tree end was adjusted to improve the alignment of the brayer. This and other hangers were reinforced by the insertion of stainless steel threaded bar where splits in the timber had developed over time on their mortised ends.

The neck bearing consists of a cylindrical upper end of the spindle casting (about 4" in diameter), held within four shaped hardwood wedges, one of which is removable (and was missing), presumably to allow routine lubrication of the bearing. These are retained within an octagonal cast iron housing, which in turn is wedged into the eye of the bed stone by four shaped oak segments. The bridge tree was dropped by releasing the screw end of the brayer and taking out the wedges supporting the bridge tree hanger beam. The lower spindle end was thus released from the bridging box, which could be removed by unscrewing the four bolts attaching it to the bridge tree.

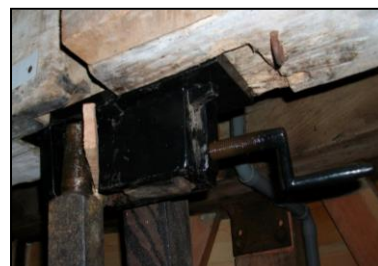
The gap between the hackle plate and the upper surface of the neck bearing was packed with rope soaked in petroleum jelly (non-toxic) to prevent meal from entering the bearing. The runner stone was then eased back onto the mace and the quant refitted. The glut box was re-fixed further back on the sprattle beam in what appeared to be a previous position, requiring the bolt holes to be re-drilled (see right). The stone nut then had the correct clearance at the tailwheel cogs, and the stone turned with the sweeps. The bed stone fixings were reinforced and the rest of the stone gear re-installed. The renovated governor was re-fitted with a new drive belt, and the tentering gear adjusted for correct operation.

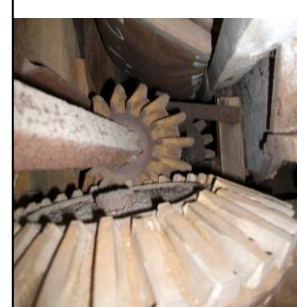
### Bevel gears driving the vertical shaft

Drive from the tail wheel is distributed on the right side of the mill via a system of perpendicular shafts and belts on mostly hardwood (LV) bearings.

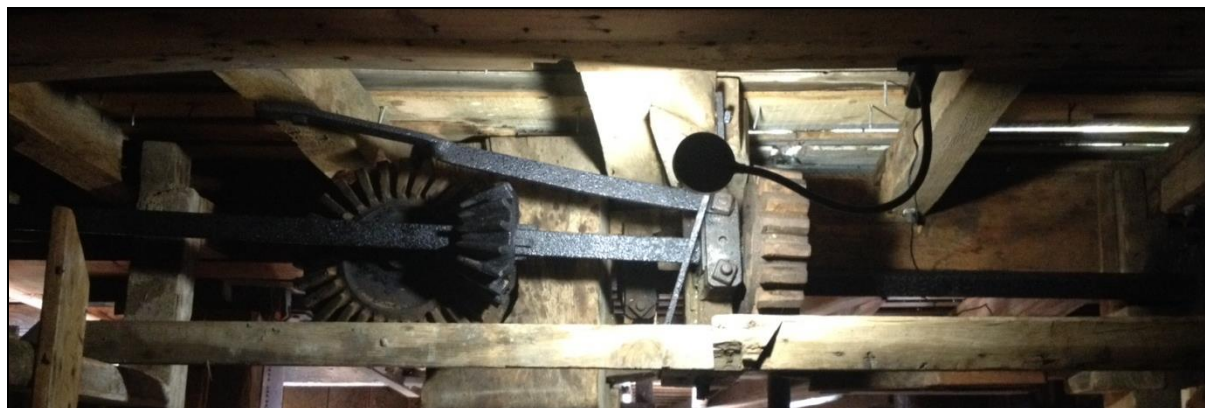
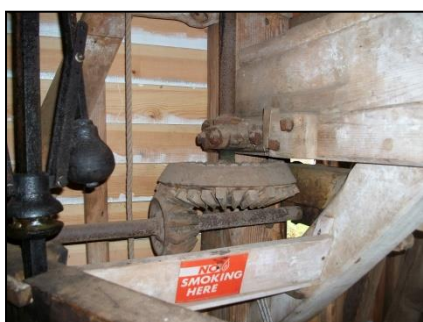
The auxiliary drive system provides power to the smutter, dresser and crusher from the side cogs on the tail wheel via a lever-engaged cast iron pinion, off to the left in the picture below. The bevel gear the takes the drive down to the crusher on the spout floor. The gears to the right of centre drive the smutter pulley off to the right. These are supported in gunmetal bearings that are braced with wrought iron straps bolted to the side members. This part of the drive is normally concealed under the sloping side panels of the smutter bin.

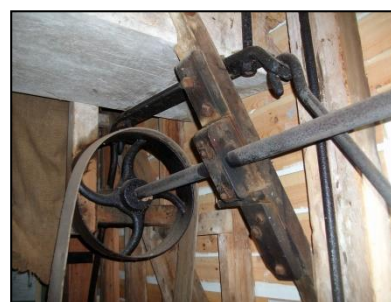
The downshaft terminates in bevel gear (left) driving the crusher pulley (right), whose shaft is supported in hardwood bearings. The driven gear can be disengaged via a horizontal lever mounting on the rear end of the pulley shaft to reduce the load on the system if the crusher is not in use.

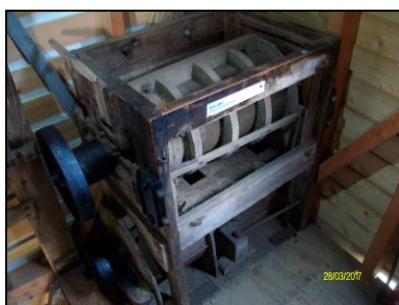
*Smutter showing belt drives, drum and fan below*

The smutter was found to be substantially complete and in working order, except that its side and top panels, pulley belts and upper drum end baffles were missing. These can all be easily replaced if required. The bearings were fully functional after light lubrication. All parts of the smutter had evidence of woodworm infestation, but with remarkably little structural or functional damage resulting. The grain outlet spout below the machine was also in good condition. The side cogs of the tail wheel would need renovation to operate the drive system. At the time of writing, the exhaust vent in the mill side has not been reinstated. There may also have been an air inlet vent in the mill back wall but there is no evidence of this in the records available (old photos of the back of the mill), so air would probably have been drawn from the mill interior, helping to clear flour dust. A new (hardboard) inlet spattle was present on the grain inlet which could have been operated by a rocker and cord from the floor below, but there was no evidence of this actually being connected up, there being no hole in the floor or twist peg fitted below, so this will also not be reinstated.

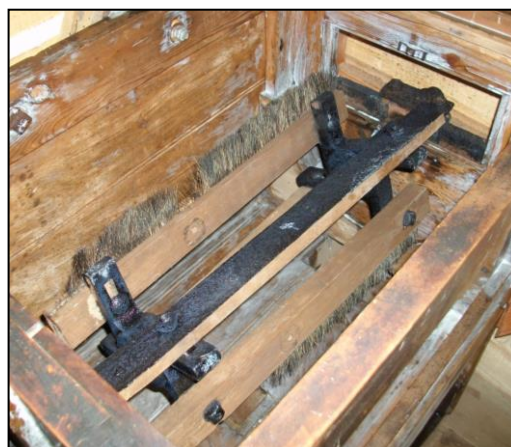
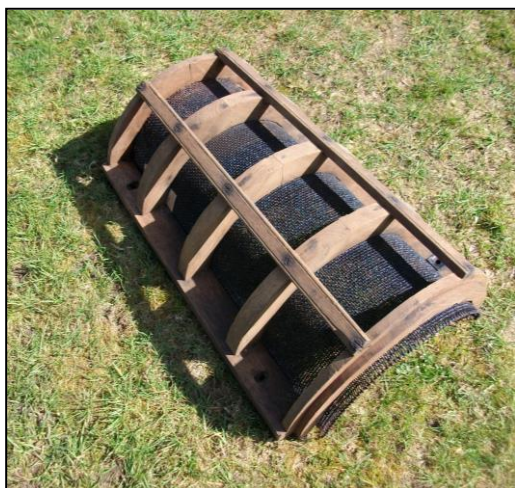
*The picture right shows the brush and agitator with offset attachment to the smutter spindle; the offset showing that it was driven in the anticlockwise direction.*

*The picture left shows half of the smutter drum after preservation, with five elm rings supporting the coarse mesh lining.*

The smutter drum was removed by releasing the four bolts that hold the halves together and rotating them. The mesh was sound, where not covered by the zinc sheet, if somewhat corroded. The drum halves were treated with 'Fertan' to preserve the steel mesh, including the wood, to ensure full penetration and to act as a preservative, as were all other accessible iron parts. The softwood frame and remaining panels of the smutter itself were treated with PVA to seal the surface, deter pests and reinforce the joints. The drum bolts appeared hand forged with irregular nuts, but the general construction of the smutter was of a similar high standard to the dresser, and was probably from the same supplier. The smutter was reassembled with the internal components visible to visitors.

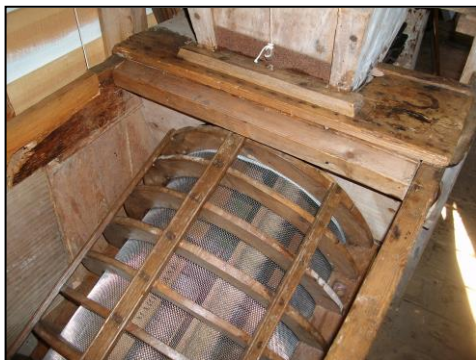
The machine was reasonably intact when initially inspected, except that, where the back of the mill structure had collapsed, the spindle bearing panel had come away and the weight of the drum had forced down the spout assembly. The end panel and bearing were fortunately found within the mill, along with the side panel. The spindle end was temporarily supported until the bearing panel could be refitted, and the collapsed spouts also provided with temporary reinforcement pending rebuilding. A pair of new joists was fitted longitudinally below the machine to support the rear end.

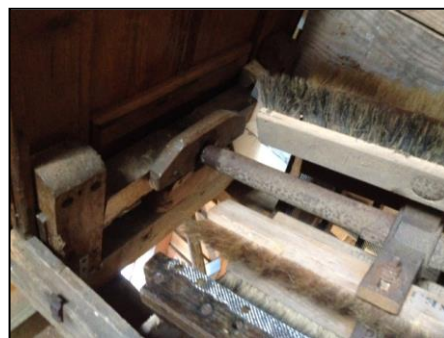
The brushes (see right) were then removed from their arms, and the spindle and arms treated with Fertan to neutralise the surface rust. The brush bars were treated with PVA. Interestingly, the coach bolts fixing the brushes to the spindle arms appeared hand forged, perhaps to provide extra-large heads, while the bolts holding the drum halves together were more regular and hence seem machine made. The lower drum support cradle board was quite worm damaged, so was reinforced with a square batten, which now takes the weight, resting on the new beams. The upper end of the drum must fit into the circular aperture seen in the picture above, so the lower cradle board had to be re-fitted at the correct angle and supported to retain the drum correctly in place, using angled side boards which also form the sides of a new bran spout.

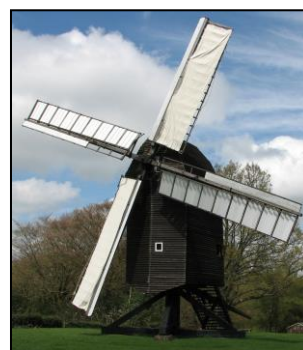
Nutley windmill is an early, relatively small post mill with an open trestle that is not enclosed with a roundhouse. It is thought to be 300 years old, with the main single oak post dated to 1570, probably recycled from an earlier mill. It was modernised in the 1880s; common sails were replaced by spring shutter sweeps. The mill currently has one pair of each. The mill is winded by hand, by raising the steps off the ground and pushing it round. It has two pairs of stones, as per Argos Hill, but no system of storage bins to feed the stones, and has a cast iron windshaft recycled from another mill; another obvious difference is that the weatherboard is tarred rather than painted.

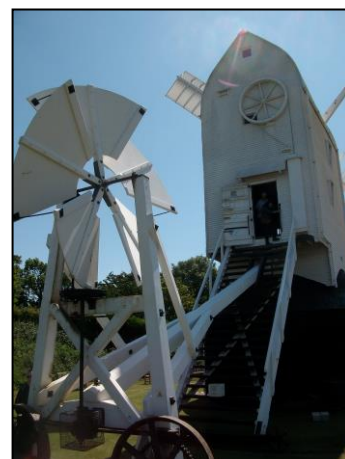
### ***Jill (1821)***

Jill is fully restored and working post mill standing on the Downs at Clayton near Brighton, was re-opened after complete restoration in 1986. It is quite similar to Argos Hill, having white weatherboard buck of standard form, tarred brick roundhouse, patent sweeps, tailpole mounted fan tackle, two pairs of stones arranged head and tail, and a composite main post. Unlike Argos Hill, it has a double height roundhouse, with the trestle raised above head height on brick piers, providing a clear storage area at ground level. The striking chain wheel is mounted on the rear of the mill, and it has a wooden windshaft with cast iron poll end (canister) attached. It also lacks the built in storage bins on the uppermost floor, but has the advantage of cast iron bridge trees, suggesting a more recent upgrade. The mill machinery has been completely rebuilt to a very high standard. Jack, a brick tower mill (see below) stands nearby, the names for Clayton mills given by visitors due to their appearance, standing on top of the downs. Jack has no working parts, but the cap and fantail have recently been refitted by new owners. It has featured regularly on film and TV.

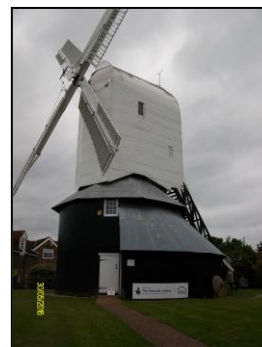
### ***Windmill Hill (1841)***

Windmill Hill windmill near Herstmonceux is the largest post mill in Sussex; it has been recently restored to working order by the owners with the aid of a large lottery grant, becoming fully operational again in 2015. It features a double height roundhouse, patent sweeps and sheet metal cladding. It has the reverse arrangement to Argos Hill, with a wooden brake wheel and cast iron brake wheel. It has a unique sweep governor which was designed to operate the striking gear automatically. Originally hand winded, it now features a tailpole mounted computer controlled electric drive.

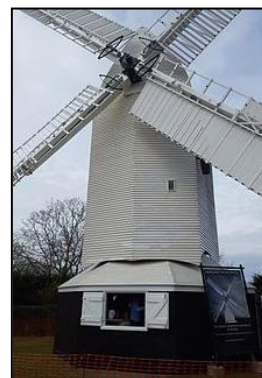
### ***Oldland (c1703)***

Oldland post mill at Keymer is claimed to be the oldest working windmill in Sussex, restored to working order in 2008, with most of the internal machinery rebuilt rather than original. The buck is white painted weatherboard of standard form, with a single storey octagonal roundhouse. It has spring shutters and is winded by hand. The cast iron windshaft was manufactured in Lewes in 1873. Pictures of a scale model and a video of flour production using the breast stones may be seen on the website.

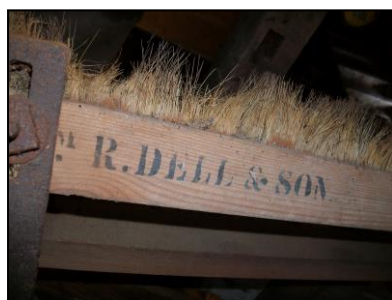
The wire machine at Argos Hill (AH) has the maker's inscription shown left. Similar machines have been seen in other local mills, such as Stone Cross. It would appear that the company supplied such stand-alone machines to various mills, and is identified on the Mills Archive as a supplier of millstones and milling machines. The address is in the city of London, near Fenchurch Street station. William is credited with co-inventing a 'conical wheat brush machine' (presumably the smutter seen at AH) in 1844, going on to establish his own business as a supplier in 1856. In 1873, his son purchased an engineering works in Croydon and went on to develop roller milling machinery, as well as importing American milling related products. The firm continued in business until the 1920s.

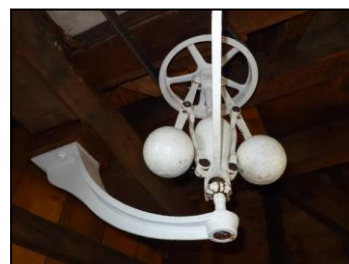
*Cast iron governor at Windmill Hill*

| GOVERNOR | Centrifugal weights lift a collar to adjust the RUNNER STONE height automatically |

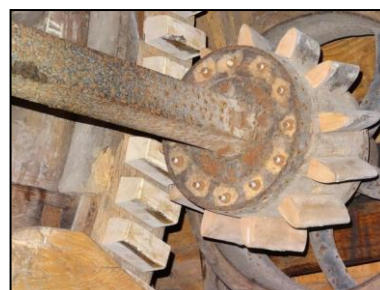
Additional machinery was often installed in local post mills to improve the quality of the flour produced, and to supply the premium product, white flour. Typically, a smutter and wire machine were added, and later, an oat crusher, but there is a great deal of variation in how this was achieved. At AH, cogs were added to the outer rim of the wooden tail wheel that engaged with skew gears on either side, driving the smutter and dresser via CI framed gears, with a final belt drive to the smutter. A vertical shaft also provided drive to an oat crusher on the spout floor via bevel gears (right). At Jill, a lay shaft was added laterally behind the brake wheel that engages with its existing cogs via a skew gear (right). This drives a dresser mounted across the rear of the mill. At

Windmill Hill, the smutter is also belt driven from a similarly mounted skew gear and pulley. Brill windmill has a stub mounted skew gear driven from the brake wheel, with a two stage belt drive to a rear mounted dresser. AH therefore seems unusual in the complexity of the auxiliary drive system. At other mills, perhaps where the buck was built slightly larger, additional machines have been fitted inside the existing body, while at AH an extension was necessary. This also incorporated a rear tunnel to access the bin floor, which allowed large feed bins to be built in. The wire machines (flour dresser) installed at other post mills in the area seem to be similar to that at AH, as supplied by William Dell of London. The construction quality of this is impressive; for example, the longitudinal bars holding the rings of the drum in place are carefully string moulded. The method of driving these machines, however, varies a great deal, depending on its position and the drive system used for the auxiliary machines.

*Skew gear and transverse layshaft driving additional machines at Jill*
